Risk assessment case study

Březnice, Czech Republic

Risk assessment case study – Březnice, Czech Republic

This case study report presents a risk assessment of the drinking water system in Březnice town, the Czech Republic. Březnice is located in central Bohemia, 80 km Southwest of Prague, with a population of 3500. Total drinking water production in the system is 380-520m³/day. Water is abstracted from three groundwater sources located around the town, water from two sources is treated to remove iron and manganese and disinfected with chlorine gas; water from another source is only disinfected with sodium hypochlorite.

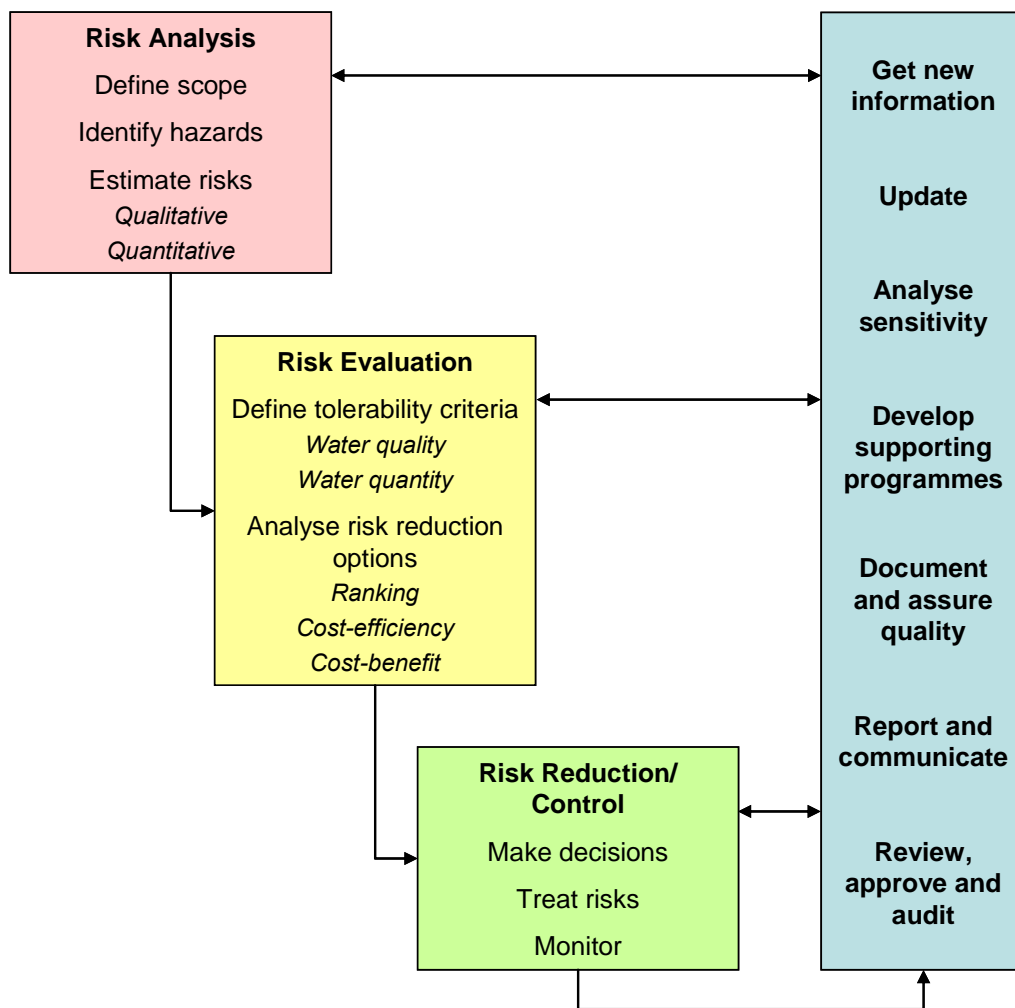
Fig. 1. The main components of the TECHNEAU generic framework for integrated risk assessment in WSP (Rosén et al., 2007).

Within Work Area 4 (WA4) Risk Assessment and Risk Management, in the TECHNEAU project, six risk assessment case studies were carried out at different drinking water systems during 2007-2008. The aim of the case studies was to apply and evaluate the applicability of different methods for risk analysis (i.e. hazard identification and risk estimation) and to some extent risk evaluation of drinking water supplies (Fig. 1).

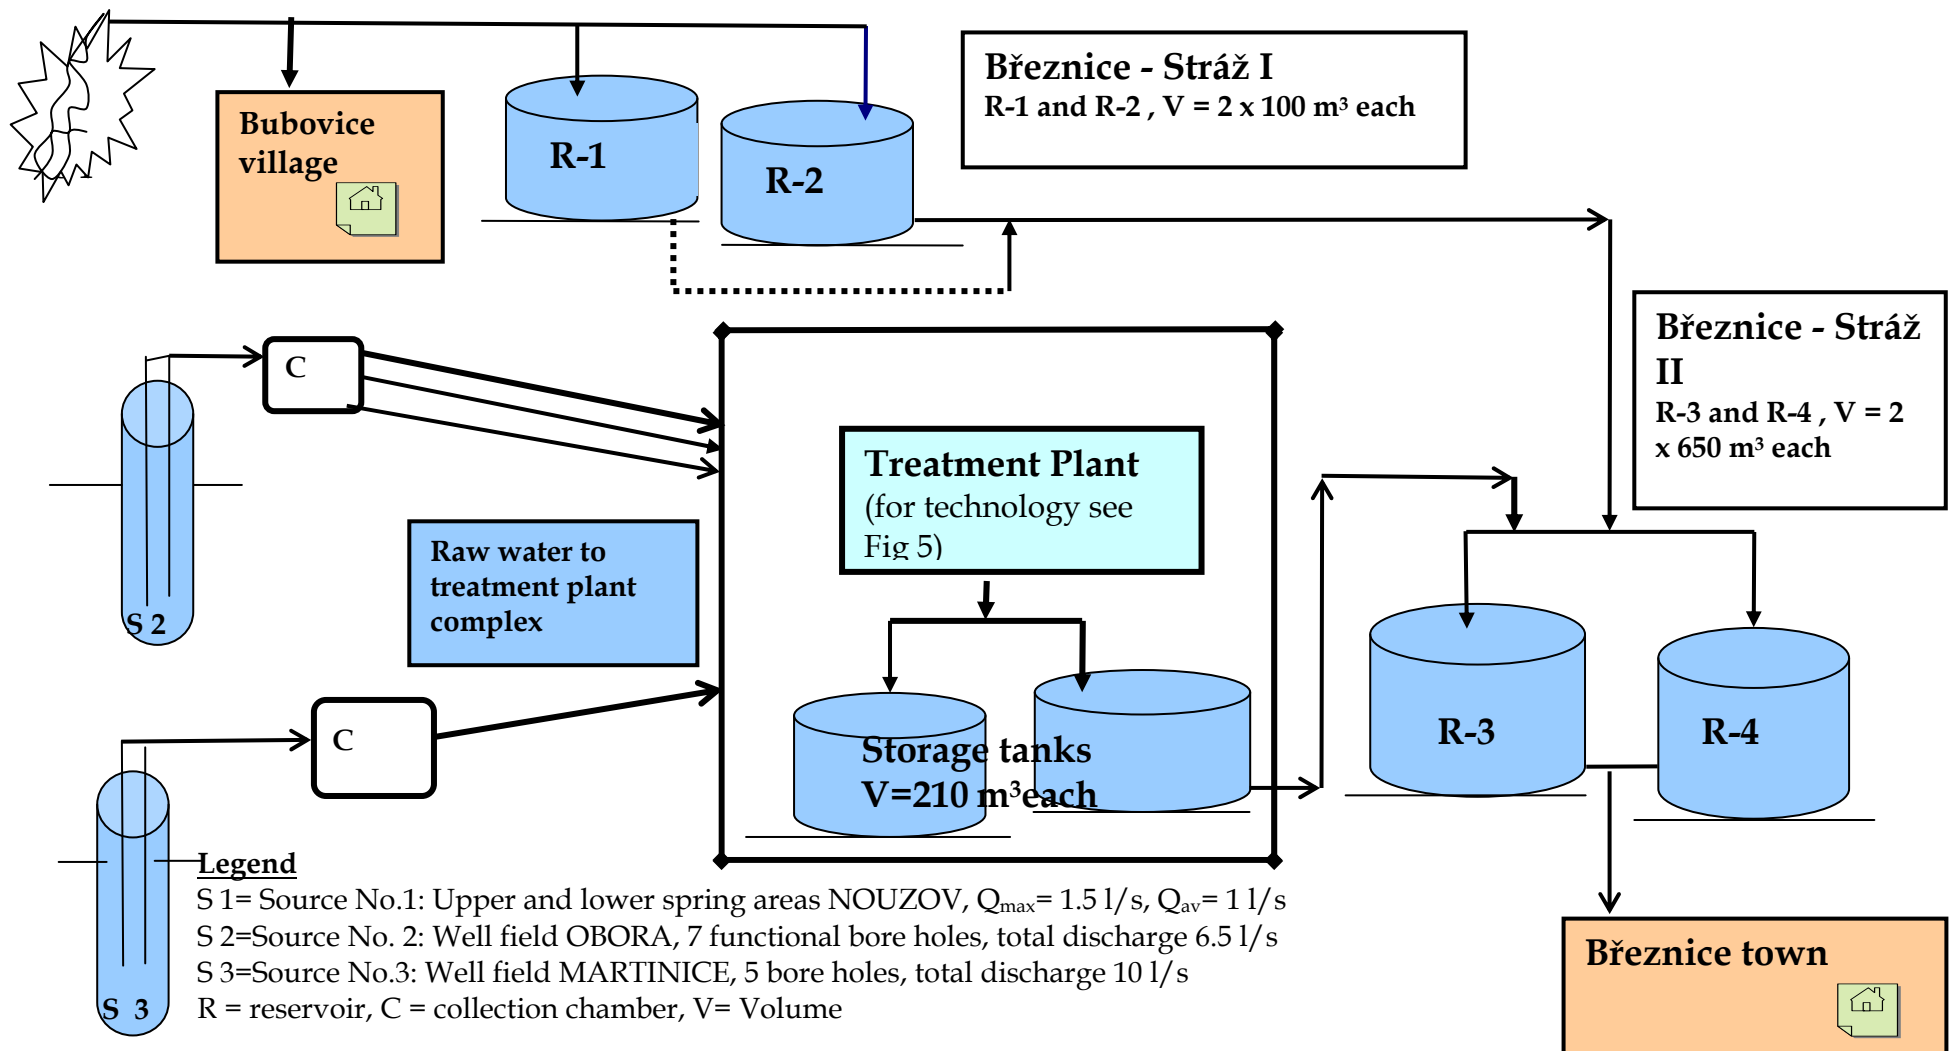
Fig. 3. Schematic diagram of the whole Březnice water supply (not scaled).

The public water system was built in 1930-1931, originally with only one source (Nouzov); two other sources were explored after the WWII (Obora, 1946; Martinice, around 1990). A schematic diagram of the water supply in Březnice is presented in Fig. 3. Beside the town Březnice, one village (Bubovice; about 200 people) is also supplied from this system – from source Nouzov. The owner of all utility infrastructures is the municipality (Březnice), but the supply system is operated under license by the professional water company Vodovody a kanalizace Beroun a.s. (VAK Beroun).

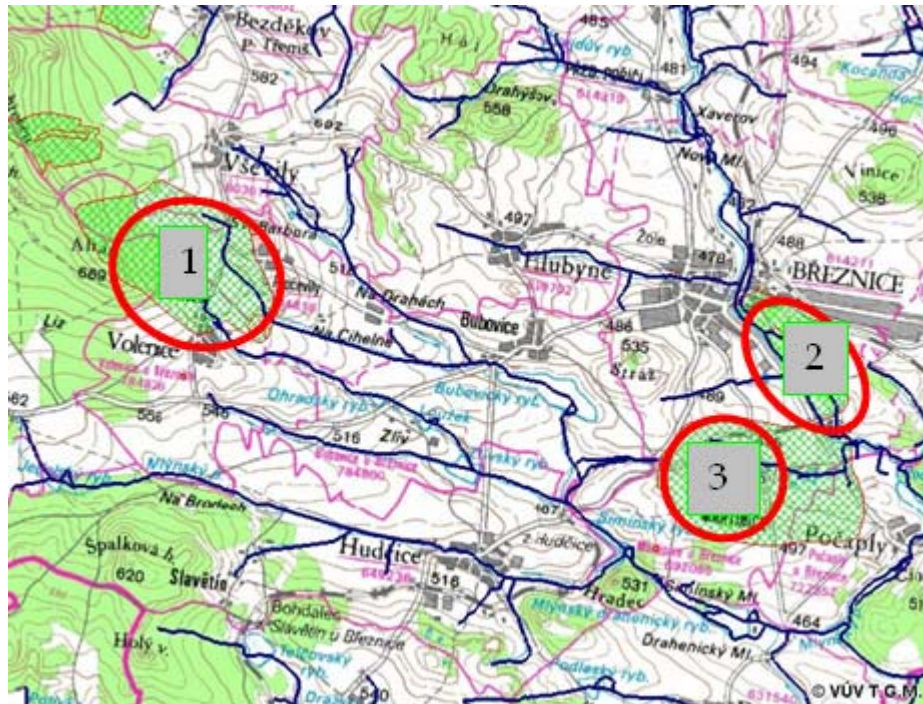
Fig. 4. Three drinking water sources and their catchments of the Březnice water supply: 1. Nouzov; 2. Obora; 3. Martinice.

The Březnice water supply system has three groundwater sources: spring area Nouzov, well field Obora and well field Martinice (Fig. 4).
