Nanofiltration for removal of humic substances

Survey on operational strategies

Lars J. Hem

D 5.3.5 B

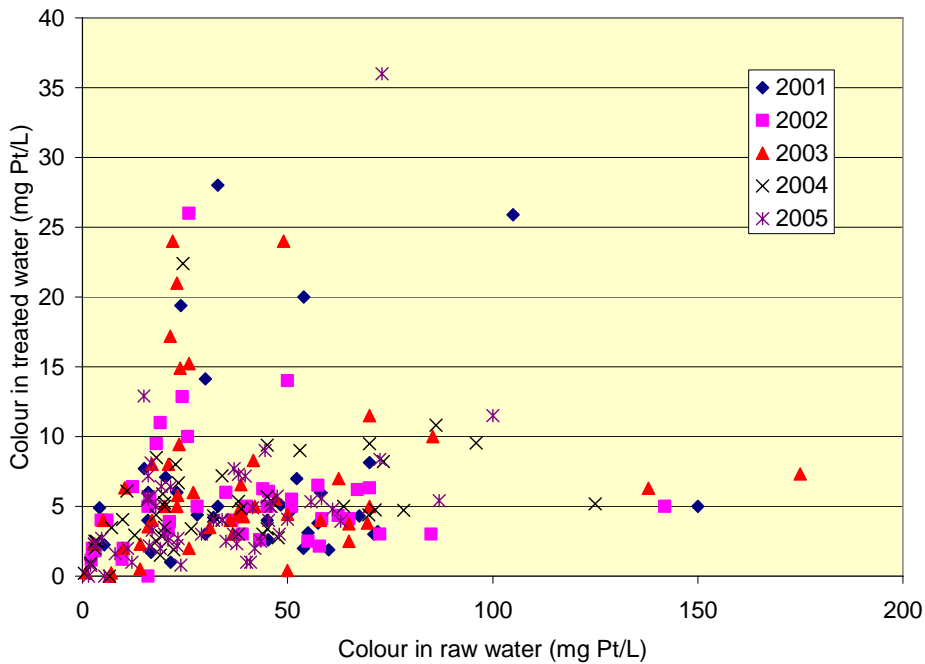
The nanofiltration plants are built for removal of colour caused by NOM/humic substances, and the colour removal will therefore be a good indicator for the general performance of the process. In Figure 2 the colour in the treated water is shown as a function of the raw water colour.

Figure 2. Yearly average colour in treated water as a function of the raw water colour

The treated water colour is mostly below 10 mg Pt/L, but occasionally the colour is much higher. There is no obvious relation between the raw water colour and the reported high treated water colour. This indicates that other factors than the raw water colour is the reasons for this malfunction of the nanofiltration plant. The figure also illustrates that the nanofiltration process may produce satisfactory permeate even with very high raw water colour levels.
