## **Nanofiltration as a treatment barrier against pathogens**

Nanofiltration as a treatment barrier against pathogens

D 5.3.6 B

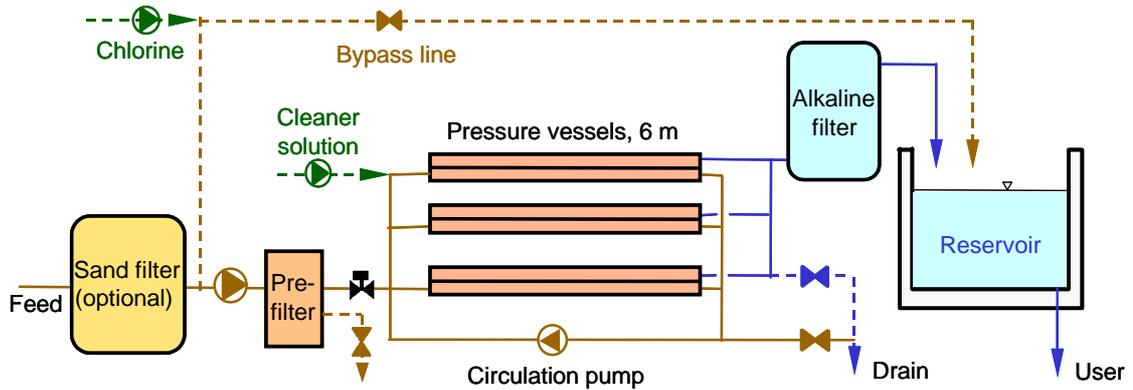
Figure 1. The typical layout of nanofiltration plants for removal of humic substances (Thorsen, 1999)

The typical nanofiltration plant starts with a pre-treatment with a 50  $\mu\text{m}$  pressure filter, and more seldom with sand filter. The next step is the nanofiltration itself, usually with two or more pressure vessels in parallel, each containing 2-4 membranes. Post treatment is pH control, with alkaline filter or dosing of sodium silicate, and disinfection, either regularly with UV or sodium hypochlorite or standby with calcium hypochlorite. Typical sampling points for physical-chemical and microbiological water quality analysis are normally located at the plant inlet and after the treated water reservoir, while the water quality will be changed in several steps in the plant.

A typical design of a Norwegian nanofiltration (NF) treatment process is shown in Figure 1. This process design is the standard for the plants included in this study, even though the pre-treatment and post-treatment may vary.
